MEETING AGENDA

Water, Sewer, and Solid Waste Committee

9 June 2026

Inframark Monthly Report

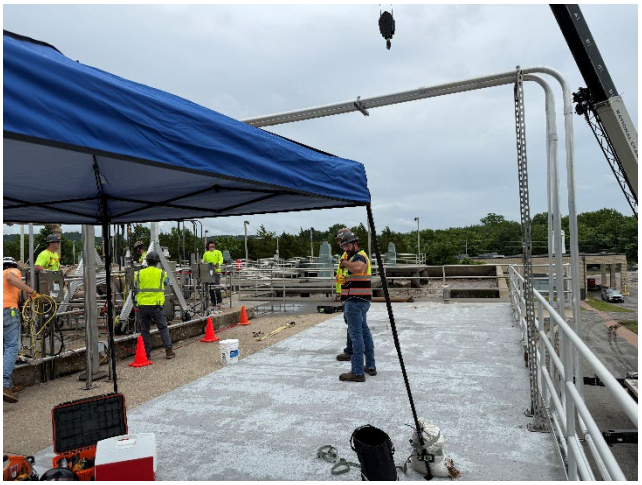
Noland RAS pumps

A constant problem at Noland is the frequency of RAS pump failure or loss of performance due to rags and debris. Staff constantly monitor and correct the RAS rates to compensate for the reduced performance of the pumps. Periodically the pumps must removed and serviced to maintain function. In late May, both RAS pumps on Aeration Basin 2 failed, resulting in "emergency action" to pull the pumps and clear the blockages.

A crane was called to Noland, and both pumps were removed from the basin to facilitate repair. Each pump was disassembled on top of the basin and debris was removed from the volutes and impellors while the crane waited to ensure the pumps could be returned to service as quickly as possible.

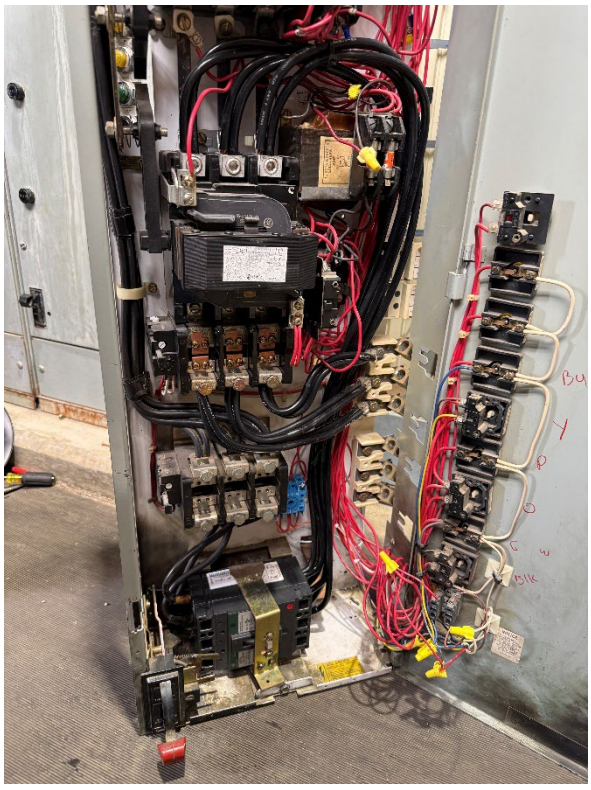
Noland Aeration Motor Control Center

The breaker supplying power to one of the critical aeration sections at Noland failed resulting in critically low levels of dissolved oxygen in Aeration Basin 1. Maintenace staff and Safety personnel immediately responded and replaced the breaker while the cabinet was energized. Once the breaker was changed, power was restored and the dissovled oxygen levels returned to normal levels.

Since the breaker is obsolete and no longer available, an older breaker recovered from an out-of-service MCC was used as a direct replacement.

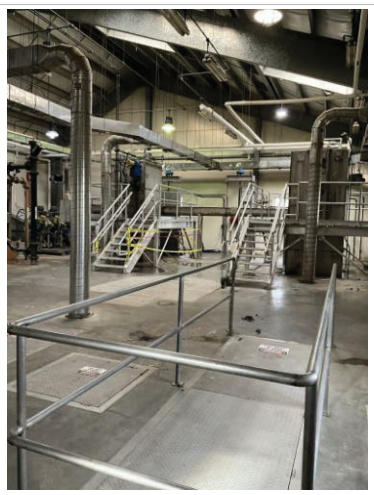
Inframark ensures the facility is well-maintained and in adequate operating conditions. One bar screen is down for maintenance but is not hindering headworks operations. A new grit auger was installed roughly four (4) months ago after the original deteriorated to inoperable conditions. All submersible mixers in the anoxic zone were repaired or replaced roughly three (3) months ago. The facility additionally operates secondary treatment with a modified oxidation ditch. Two of four oxidation ditches are in service - two are maintained on standby and are switched online once per year to keep all oxidation ditches in operational rotation. Secondary clarifiers appear in adequate condition - there is evidence of algae build-up on and around the v-notch weirs. The algae is scrubbed and/or pressure washed every two weeks in attempt to keep the algae down. There are plans in the next fiscal year to have the clarifier liners replaced. Various minor cracking is observed on concrete structures throughout the facility - there is evidence showing that some areas of cracking have been repaired. Mr. Scott Murphy is well-knowledgeable in understanding when to remediate cracking based on its severity, and the sustainable, long-term methods to remediate cracks. No leaks or seepages were observed in any concrete structure. There are no items of non-compliance throughout the remainder of the treatment process.

Photo Comment: Photo 1: Headworks building with one bar screen out for maintenance.

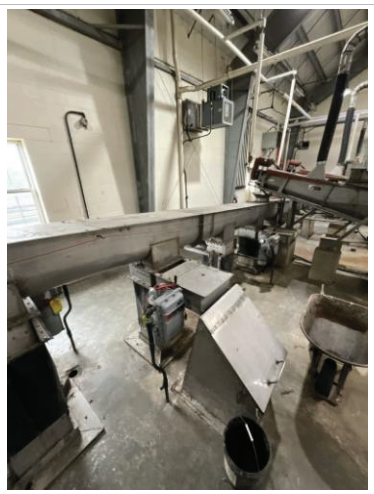
Photo Comment: Photo 2: Location where the grit auger has been recently replaced.

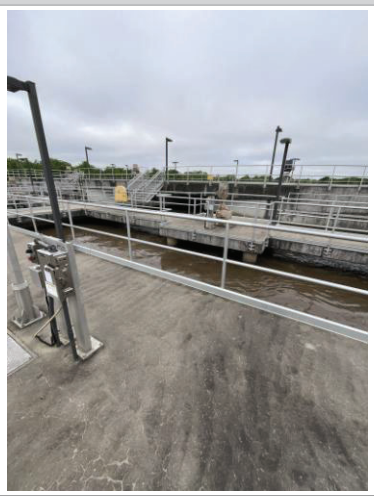
Photo Comment: Photo 3: Anoxic zone.

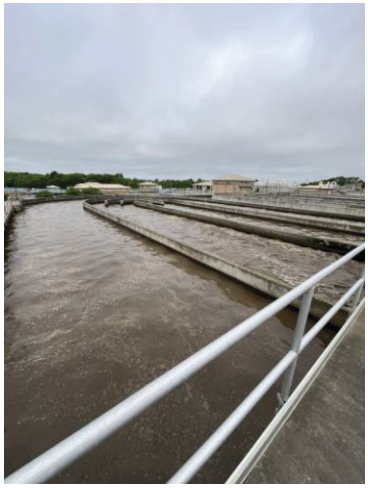
Photo Comment: Photo 4: Oxidation ditch.

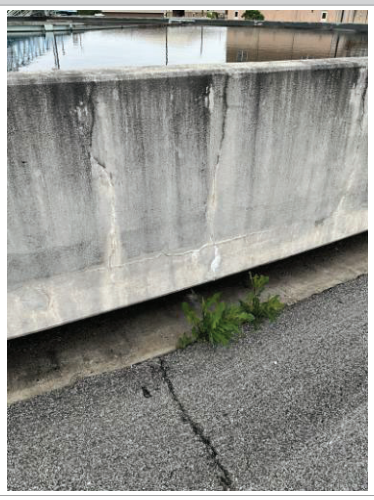
Photo Comment: Photo 6: Example of cracks on the exterior of the secondary clarifier wall.

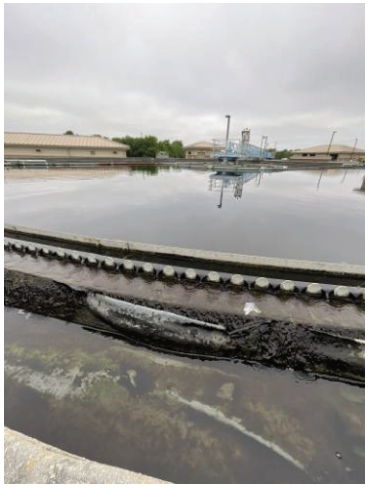
Photo Comment: Photo 7: Secondary clarifier with algae build-up and a deteriorating liner.

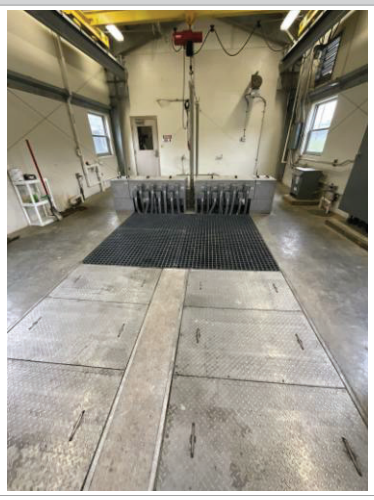
Photo Comment: Photo 9: UV disinfection building - two channels in operation.

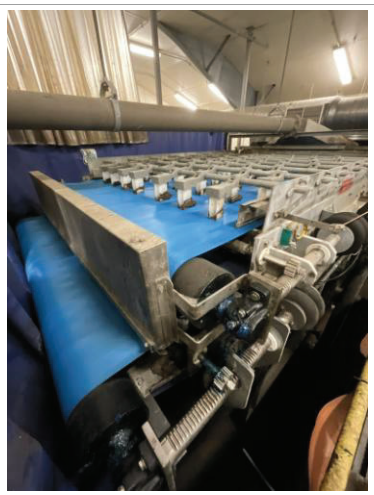
Photo Comment: Photo 13: Example of one of two sludge belt presses - the belt has thicker mesh size and different belt press material to get the highest quality product as able.
